KENTUCKY HISTORIC RESOURCES
INDIVIDUAL SURVEY FORM
(KHC 2002-1)

COUNTY Lewis
RESOURCE # Lw-56
RELATED GROUP #
EVALUATION S
SHPO EVALUATION S
DESTROYED

1. NAME OF RESOURCE (how determined): 9 / House

North side, KY. 10, about .65 miles east of intersection with Osborne Road

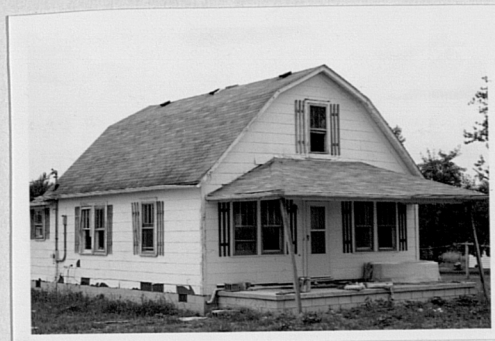
Located on the north side of KY. 10, about .65 miles from the intersection of KY. 10 and Osborne Road, this property is a 1.5 story frame, gambrel-roofed dwelling clad in composite shingles, and resting on a concrete block foundation. The house has 3/1 paired Craftsman-style double-hung wood windows on either side of the central front door; the rest of the windows are single 3/1 wood windows. Shutters are located on either side of the windows, on both the front façade and on the sides of the house. A small one-story rear section of the house appears to be original. The house has full-width front porch with a hipped asphalt shingle roof which appears to be undergoing renovation; the porch posts have been removed. The house is currently vacant.
